NBSIR 73-222 (R)

Investigation of the Skyline Plaza Collapse in Fairfax County, Virginia

E. V. Leyendecker and S. G. Fattal

Final Report

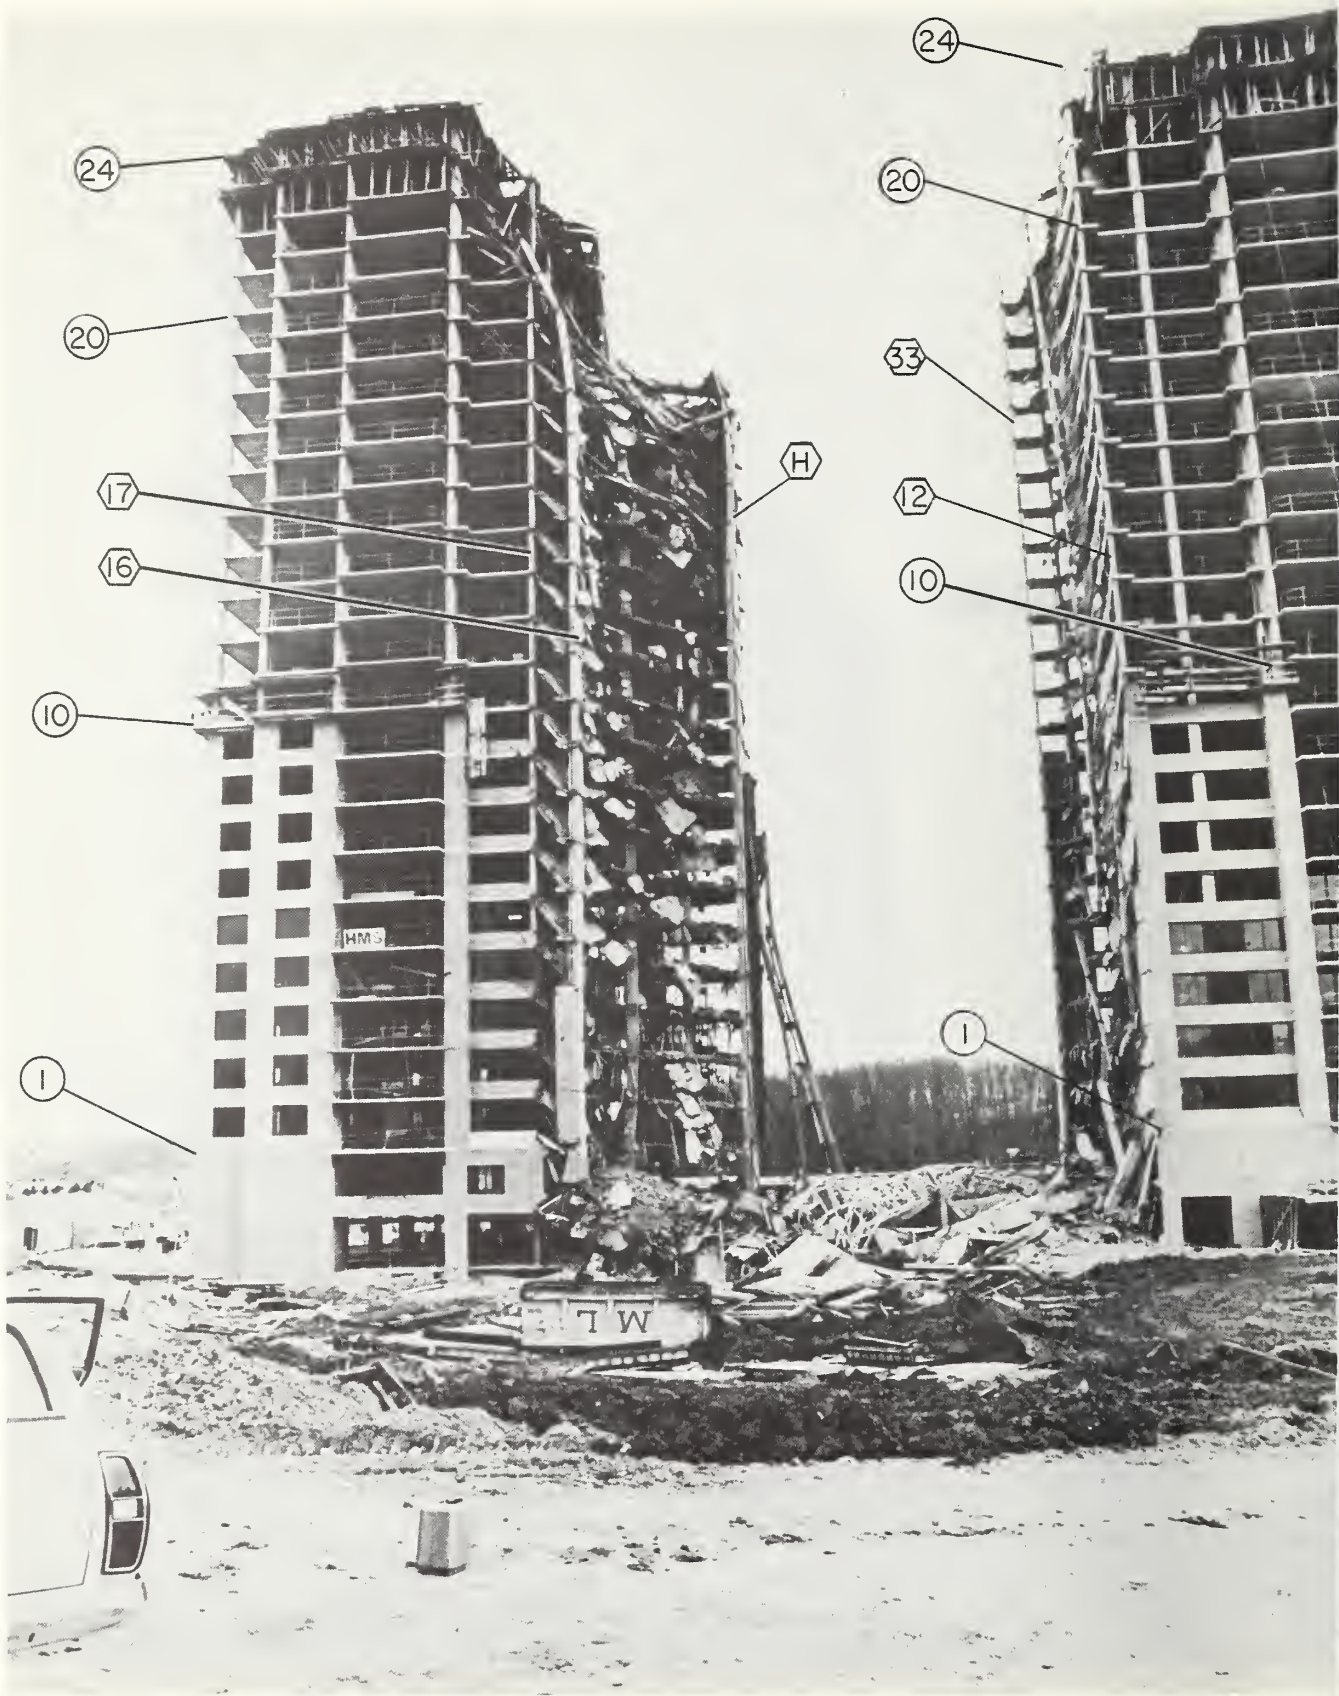
Figure 2.5 General view of the north face of building A44.

A partial view of the north face of building A-4 is shown in figure 2.5. A number of columns and floors are identified. The collapse extended between shear wall H and column 33 on the south face, a distance of about 65 ft (refer to figure 2.1). On the north face the collapse extended between columns 12 and 17, a distance of about 104 ft. Note that for most floors the slab between columns 16 and 17 did not sever from the main building but is sagging for a one-story height. Below the 20th floor, the horizontal extent of the collapse is as discussed above. Above the 20th floor, the failure zone extended slightly to the west and a greater amount to the east.

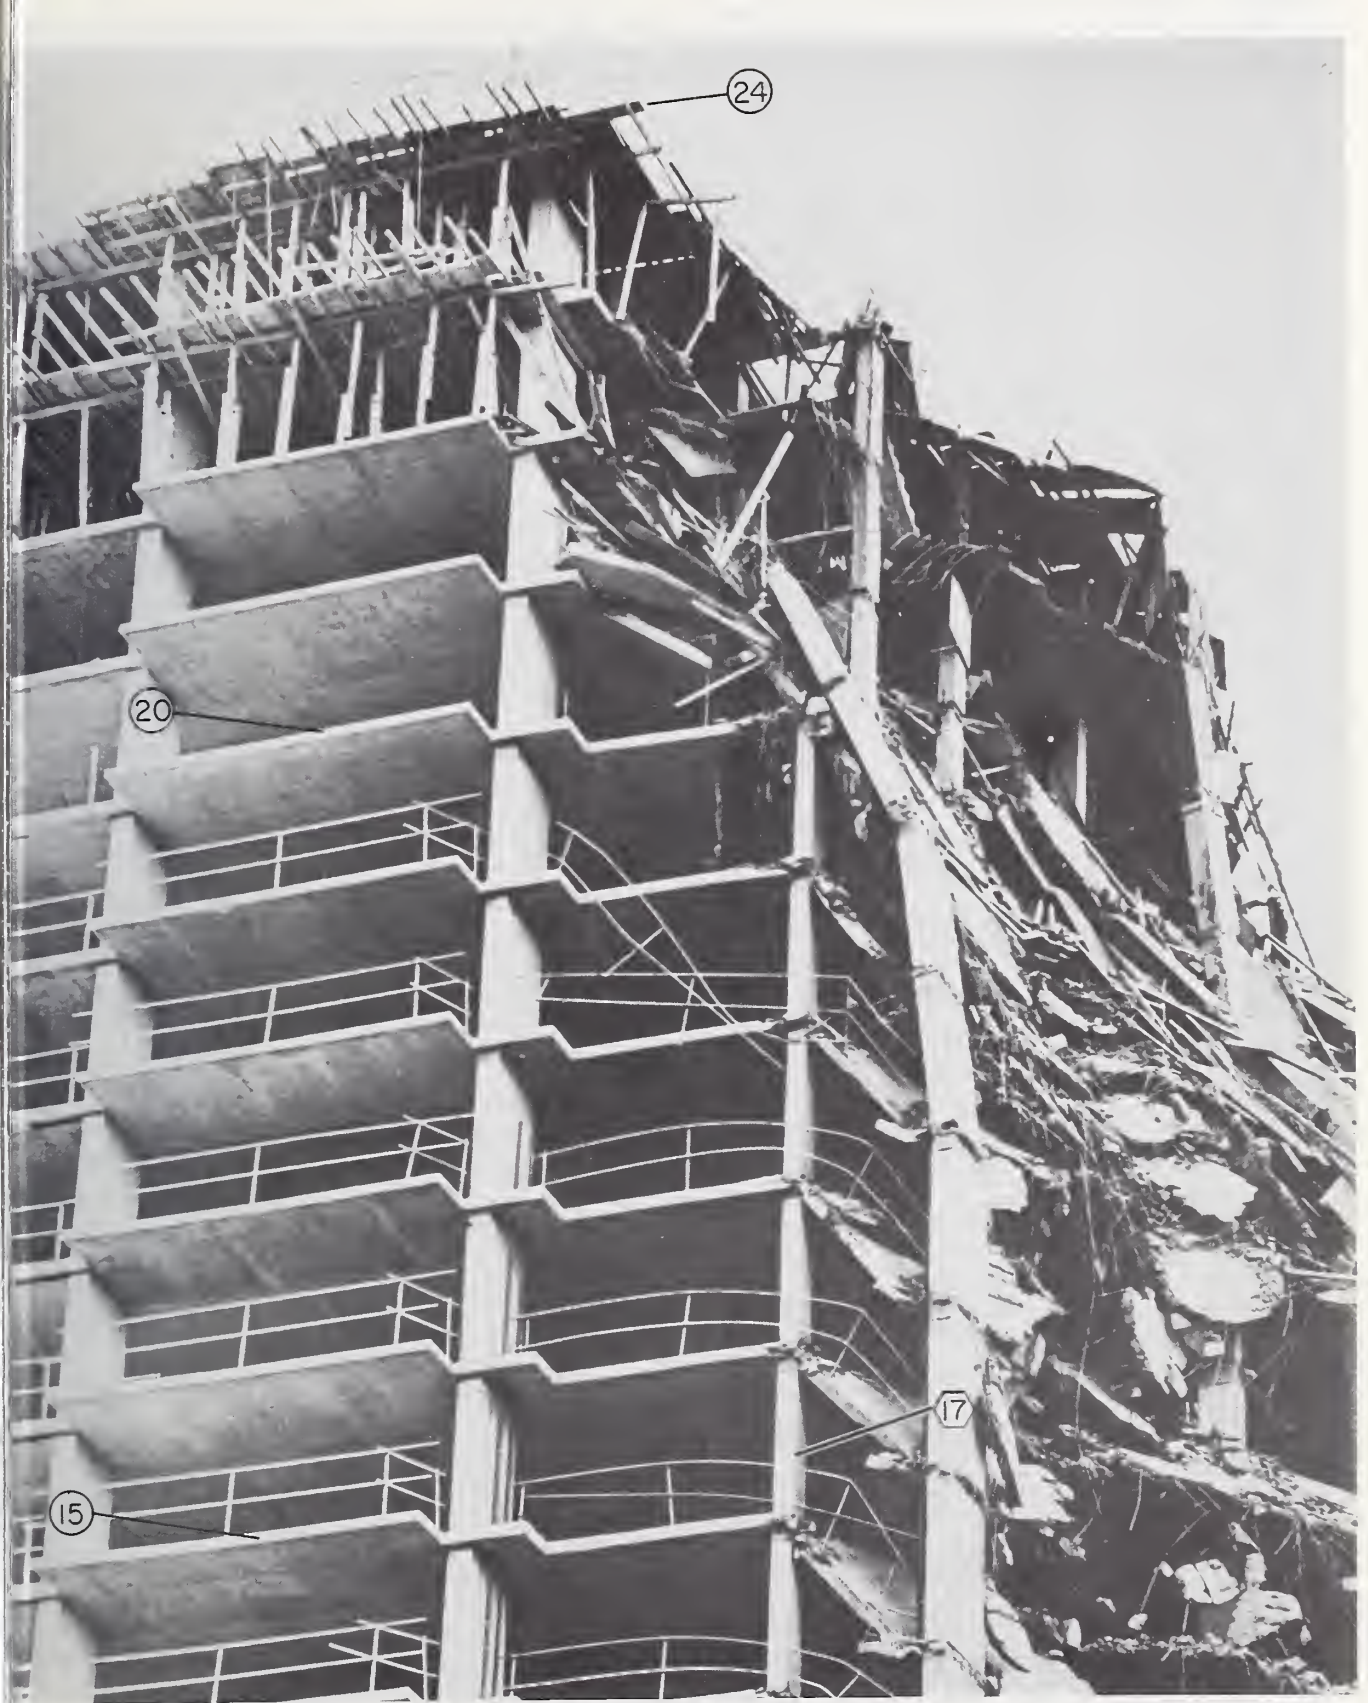
Figure 2.6 Closeup view of the top of the east end of the failure zone, looking south.

Figures 2.6 through 2.8 are closeup views of the east end of the failure zone. These figures require little comment at this time; however, it should be noted that the formwork is clearly visible in figure 2.6.

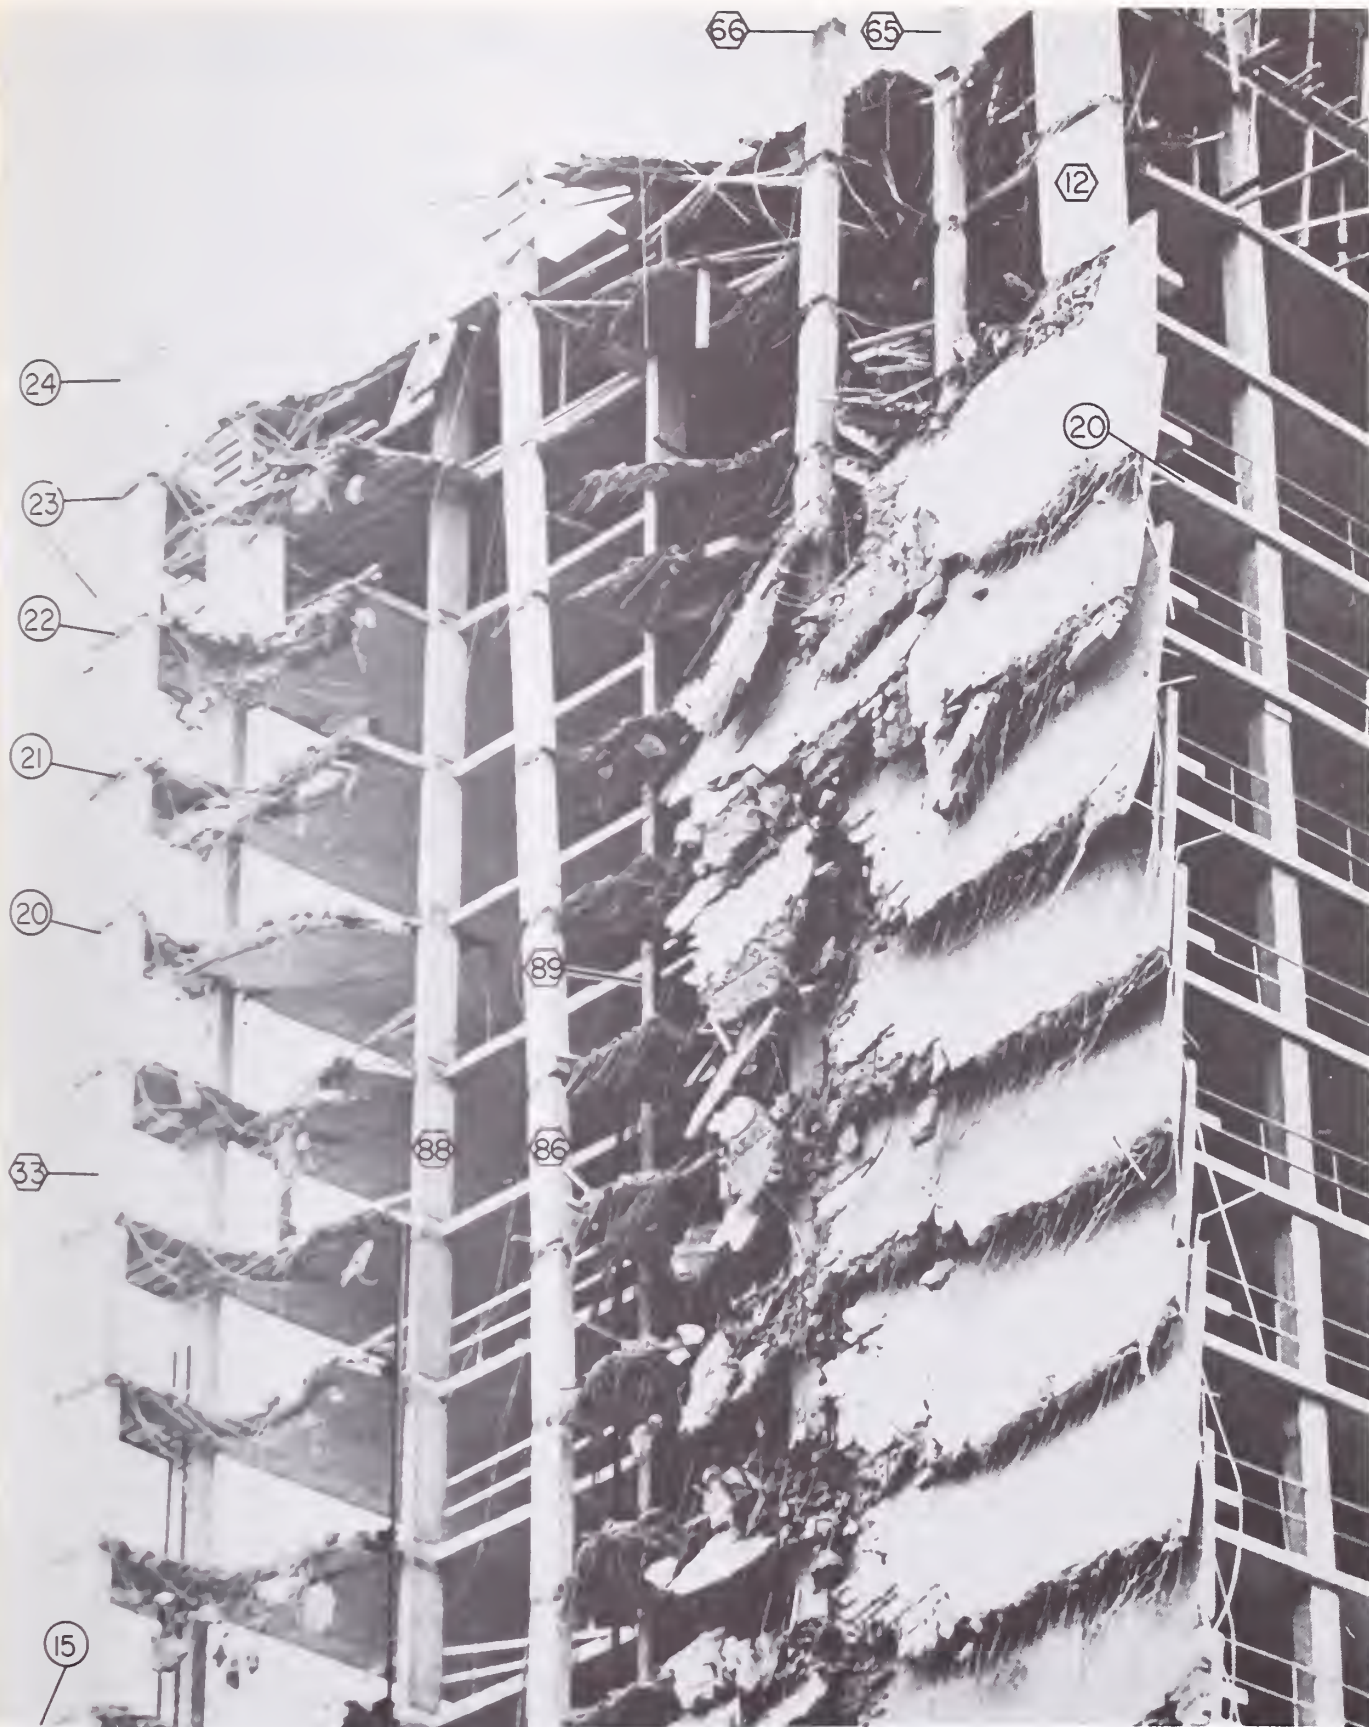
Figure 2.10 Closeup view of the top of the west end of the failure zone, looking southwest.

A general view of the west end of the failure zone is shown in figure 2.9 along with closeup views in figures 2.10 through 2.12. These figures also require little comment at this time; however, it should be noted that the formwork is clearly visible in figure 2.10.

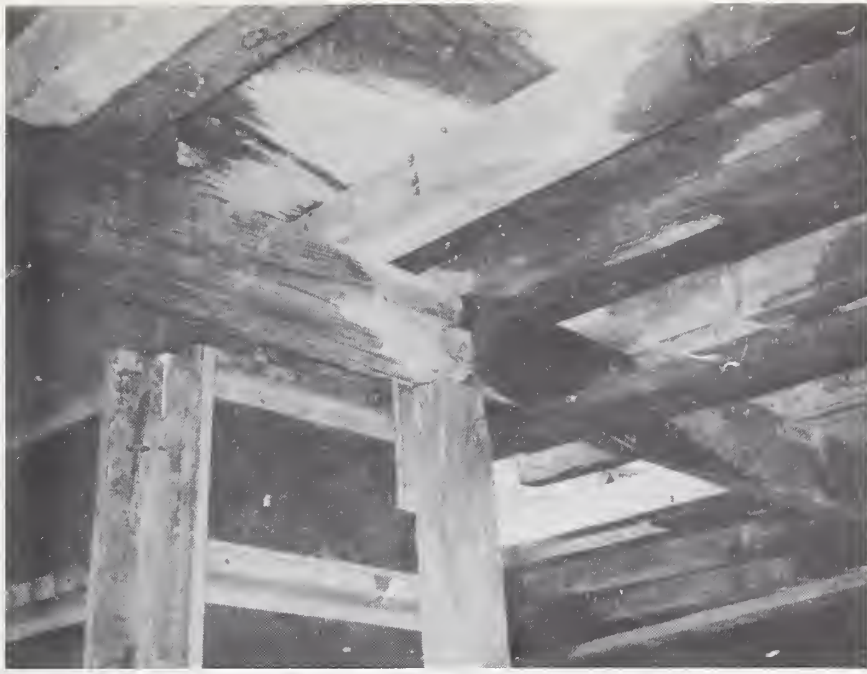
Figure 2.18 Selected details of 24th story forms.

During the NBS site inspection, a considerable portion of the lumber used for the remaining forms in the 24th story was found to be in poor condition or out of plumb. For instance, the top photograph in figure 2.18 shows a stringer with a battered end directly over the shore. The second photograph illustrates a shore which is out of plumb and has a vertical crack near the top. OSHA regulations (ANSI-A10.9, sections 8.1.24 and 8.1.25) [2] require correction of both of these conditions prior to placing concrete (which was not yet placed on these forms).

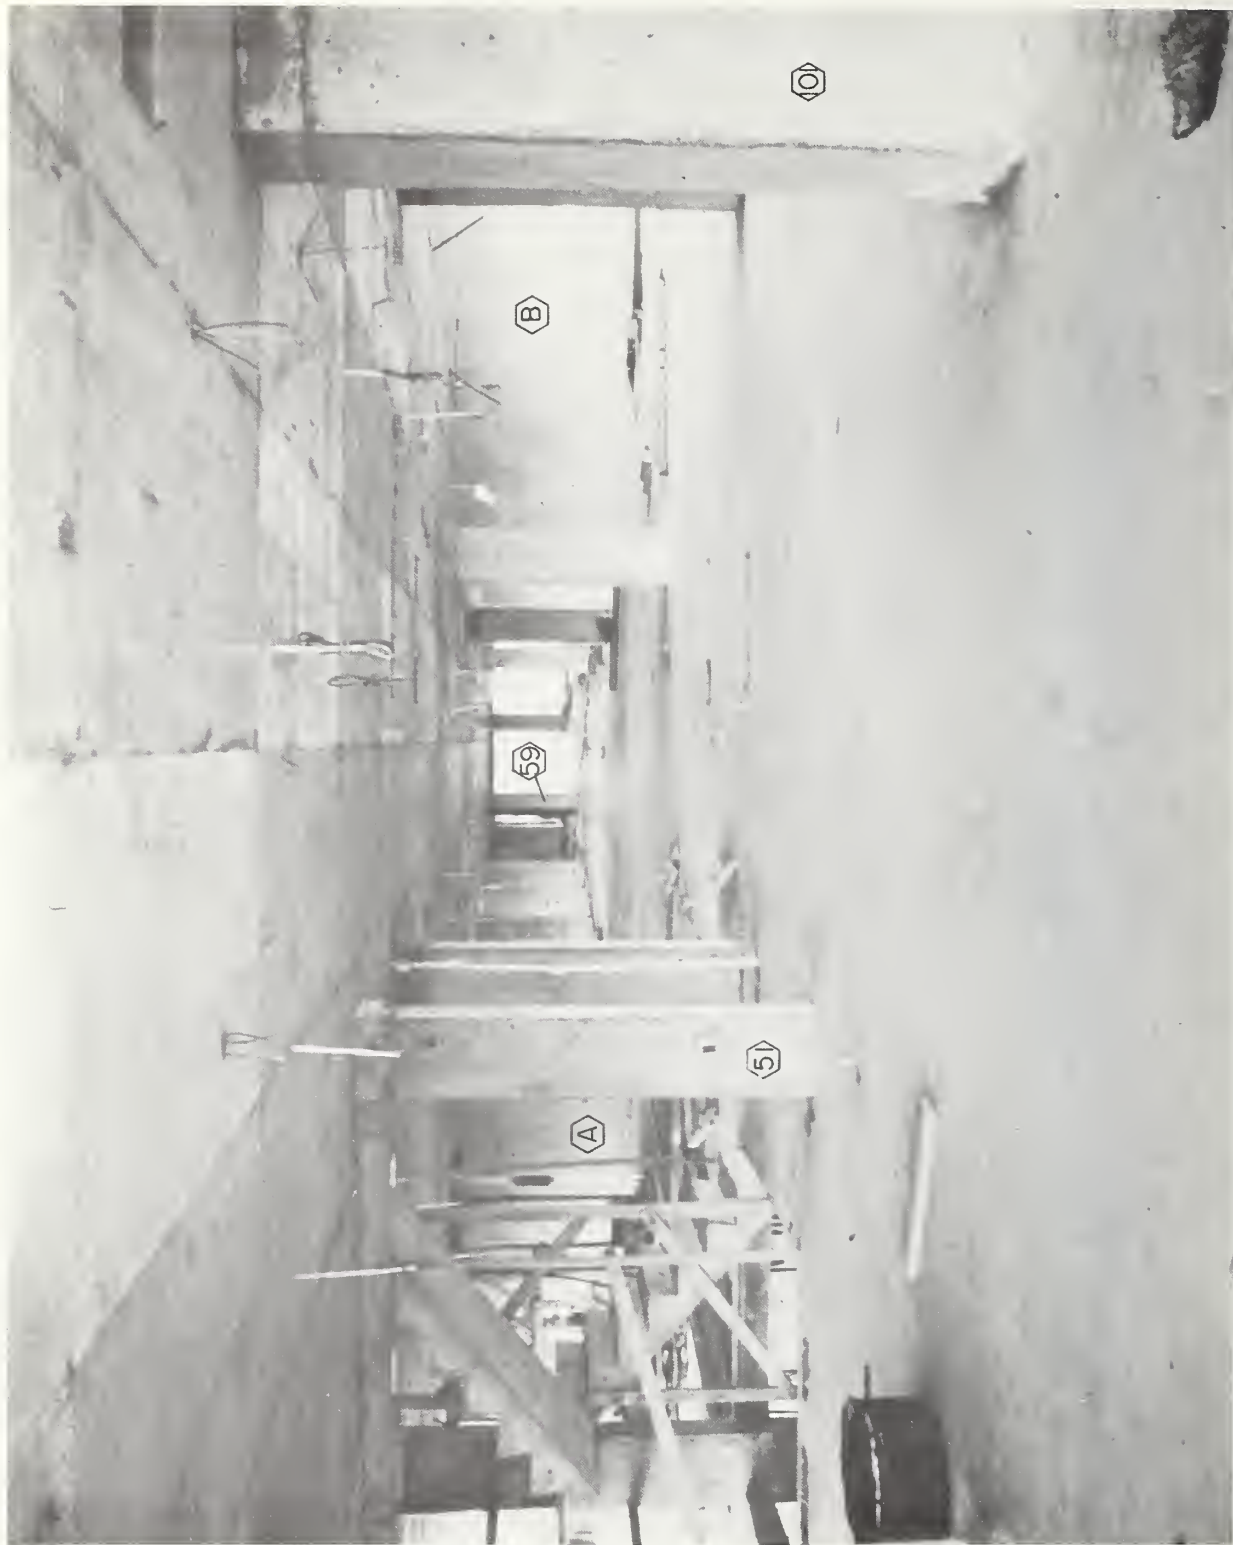
Figure 2.25 Section 1 and 2 of 20th story, looking east.

As shown in figure 2.25, the 20th floor was completely bare of reshoring. This was reportedly the case for sections 1 through 4. Note the presence of shear walls A and B. These walls were not present (the design did not require them) above the 20th story. Note also the erection crane which is barely visible to the left of the designation for shear wall A. A view of the failure section at the end of the 20th floor is shown in figure 2.26.

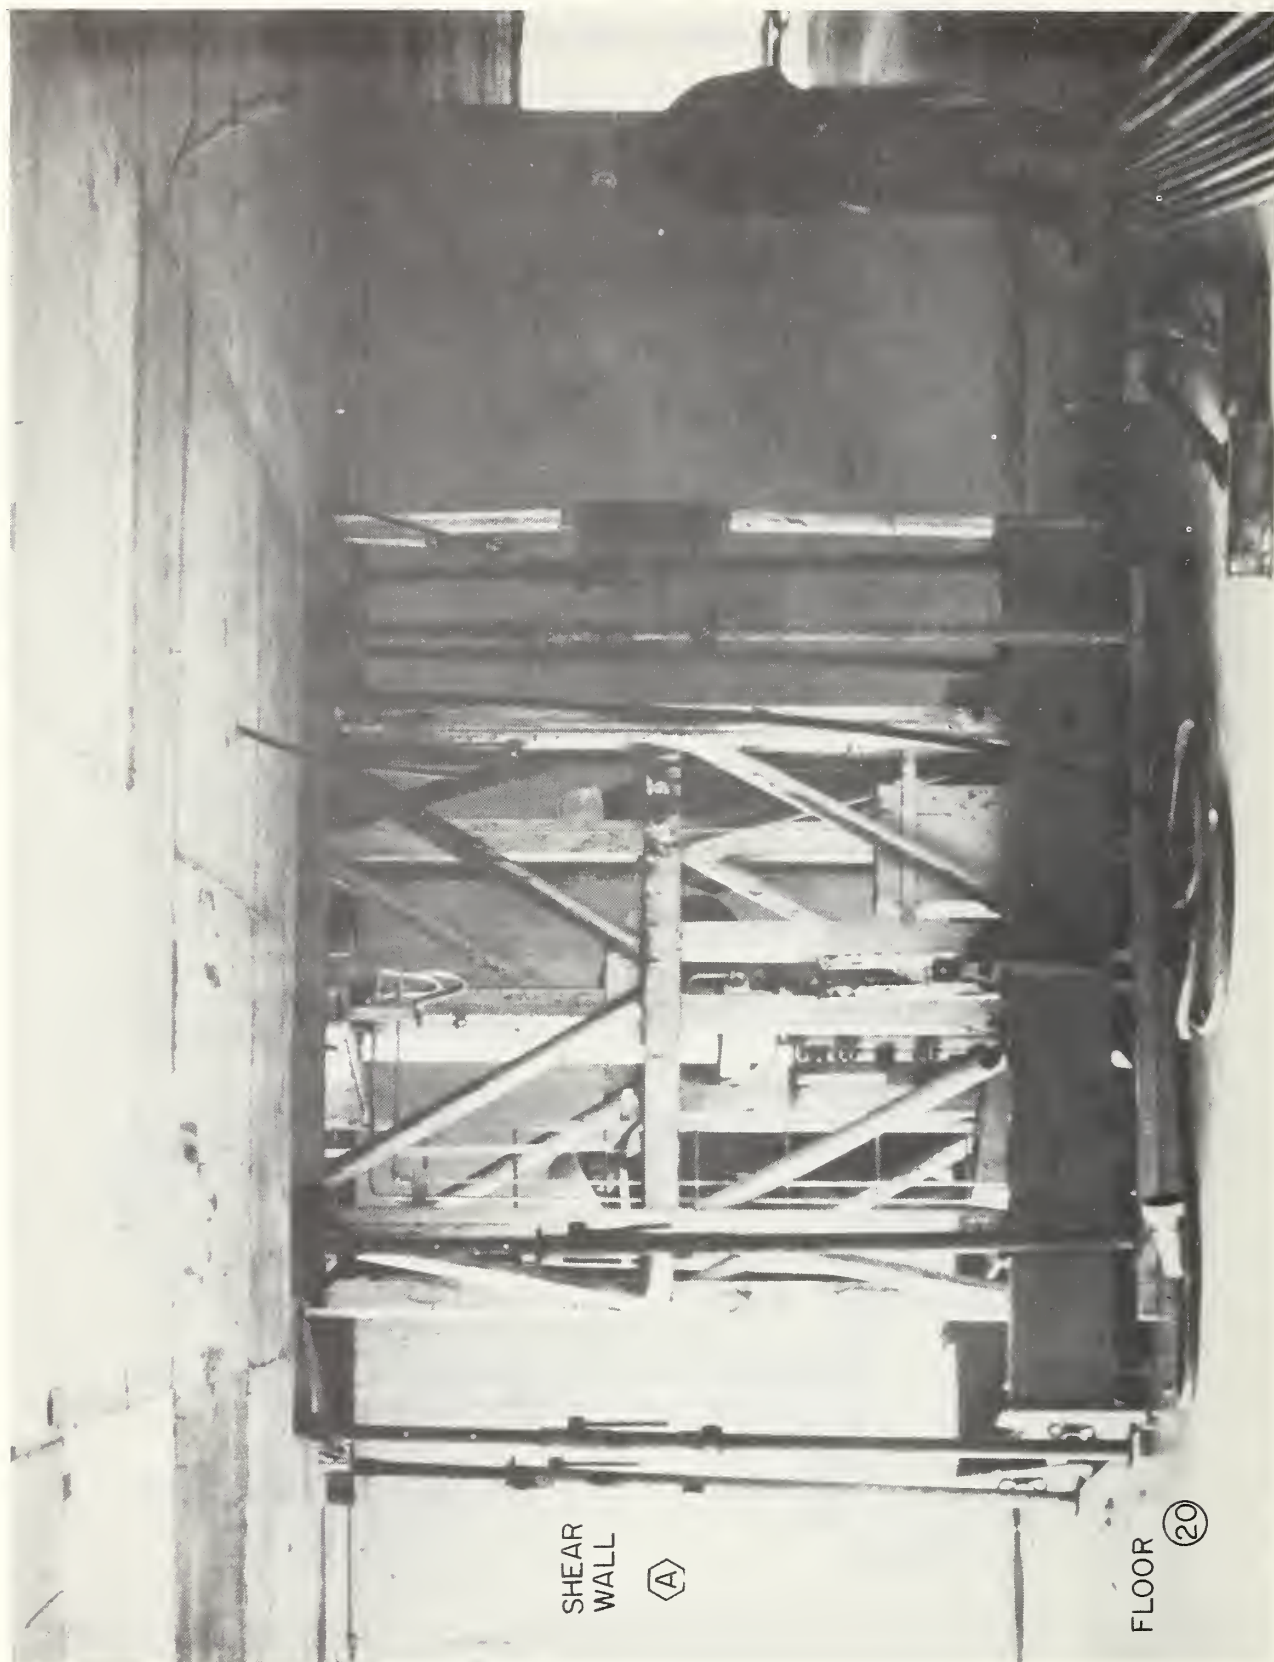
Figure 2.33 Climbing frame for crane no. 1.

Crane no. 1 was supported by the climbing frame, the lower support, on the 20th floor as shown in figure 2.33. The upper support was provided on the 22nd floor as shown in figure 2.34. This total distance is 18 ft, slightly less than the manufacturer's specified 18 ft 4 in. A typical corner clamp detail on the 22nd floor is shown in figure 2.35. Note the cracked slab where the clamp is attached.

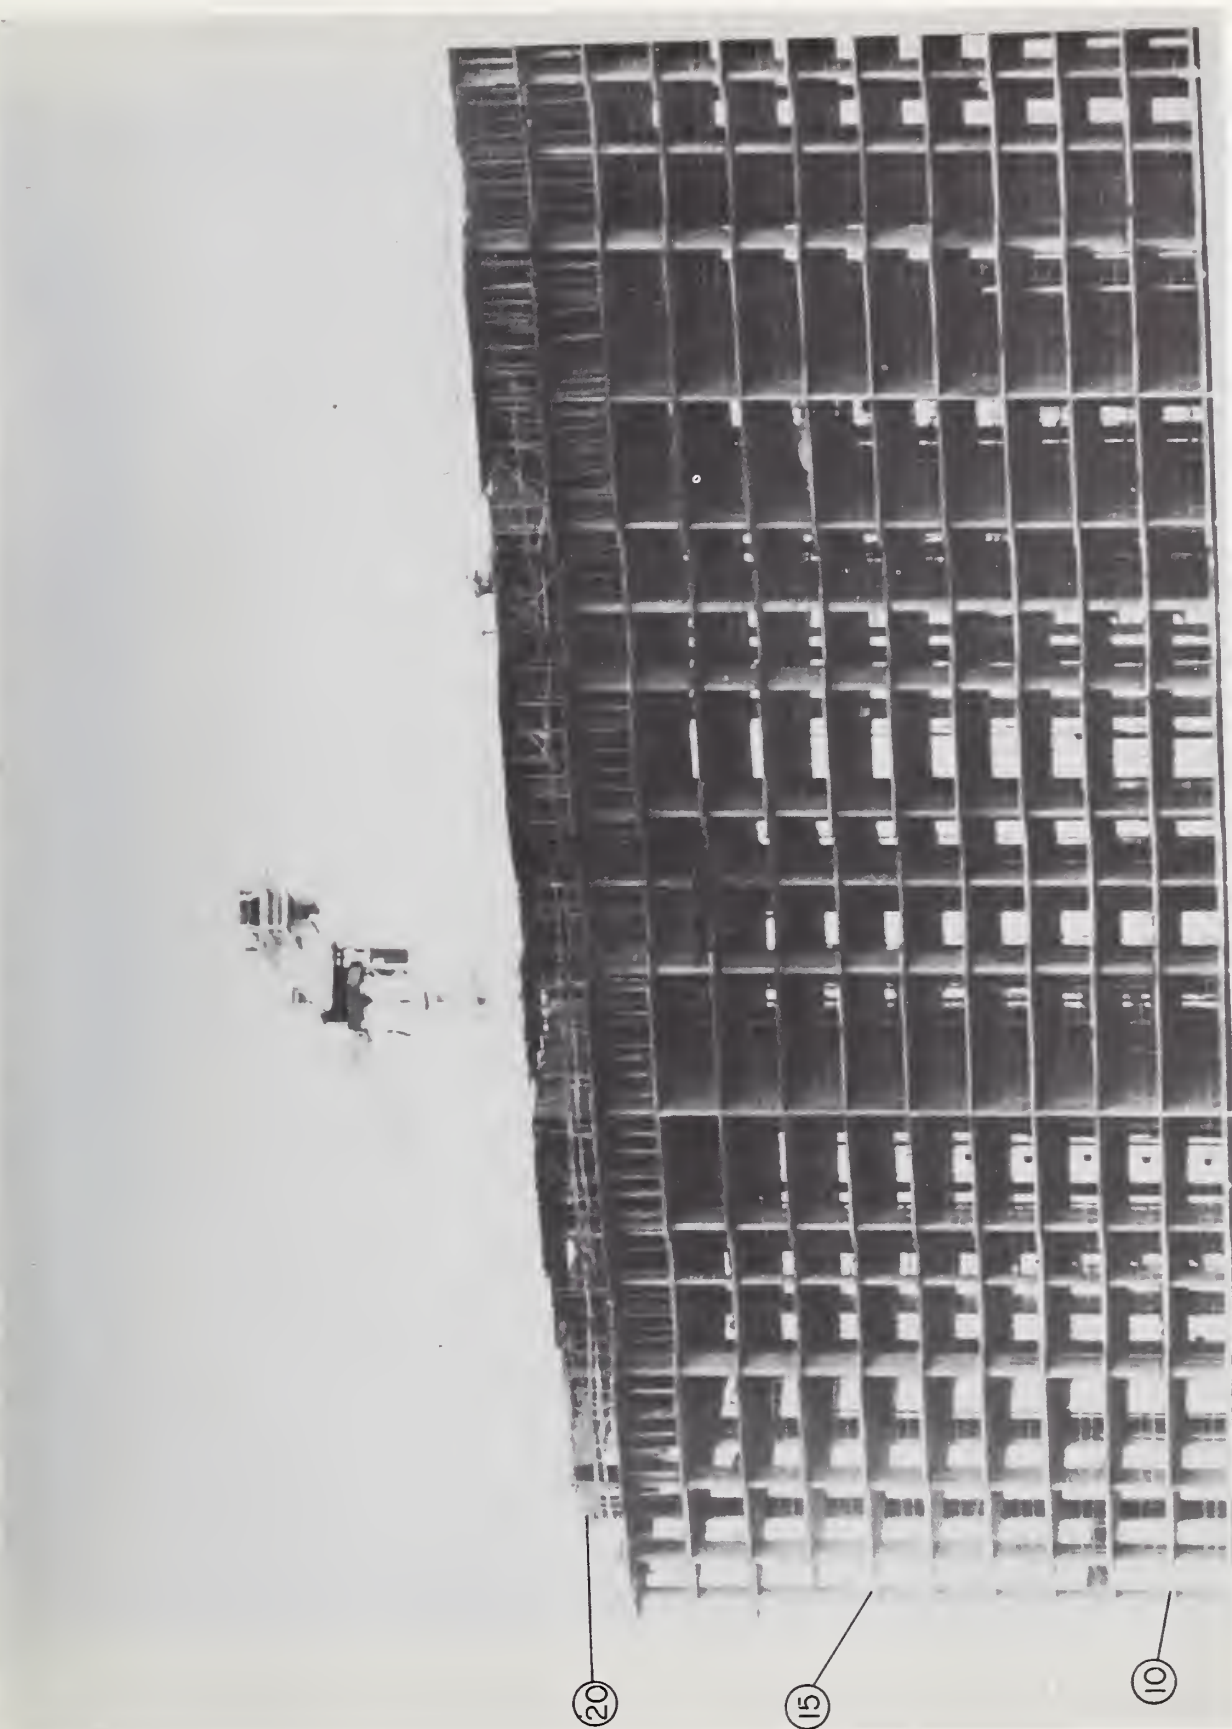
Figure 2.38 Closeup view of figure 2.36 showing crane no. 2 base support.

Examination of figure 2.38 establishes the lower crane support on the 10th floor and establishes that the crane, as installed, could operate through a ten-story height of building. It should be noted that the crane had marginal clearance to cast the 20th floor although it appears that it could. The photos were not clear enough to determine shoring conditions under the crane.

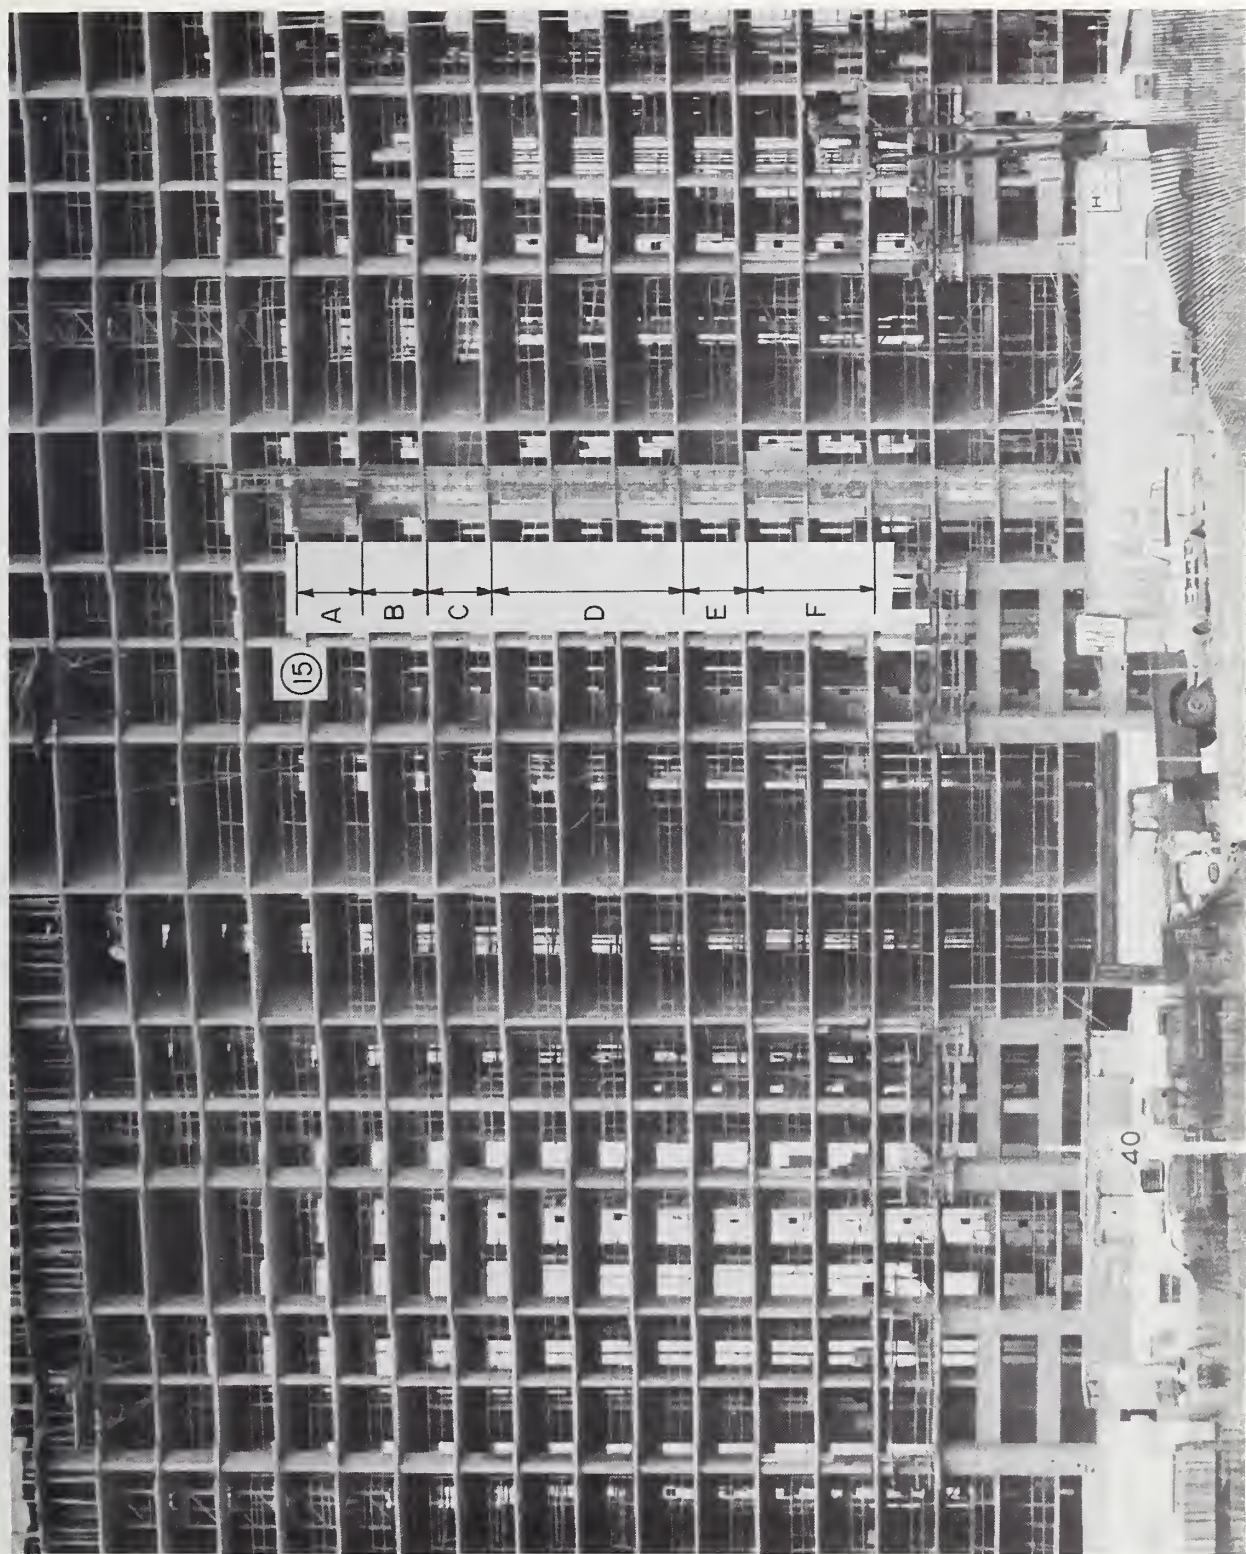
Figure 2.40 Closeup of elevator on north face.

Examination of figures 2.40 and 2.42 indicates that either the crane shoring or the formwork for the concrete closure slab of the crane opening was in place in the third through thirteenth stories on the day of the photograph. Conditions below the third story are not visible in the photograph.

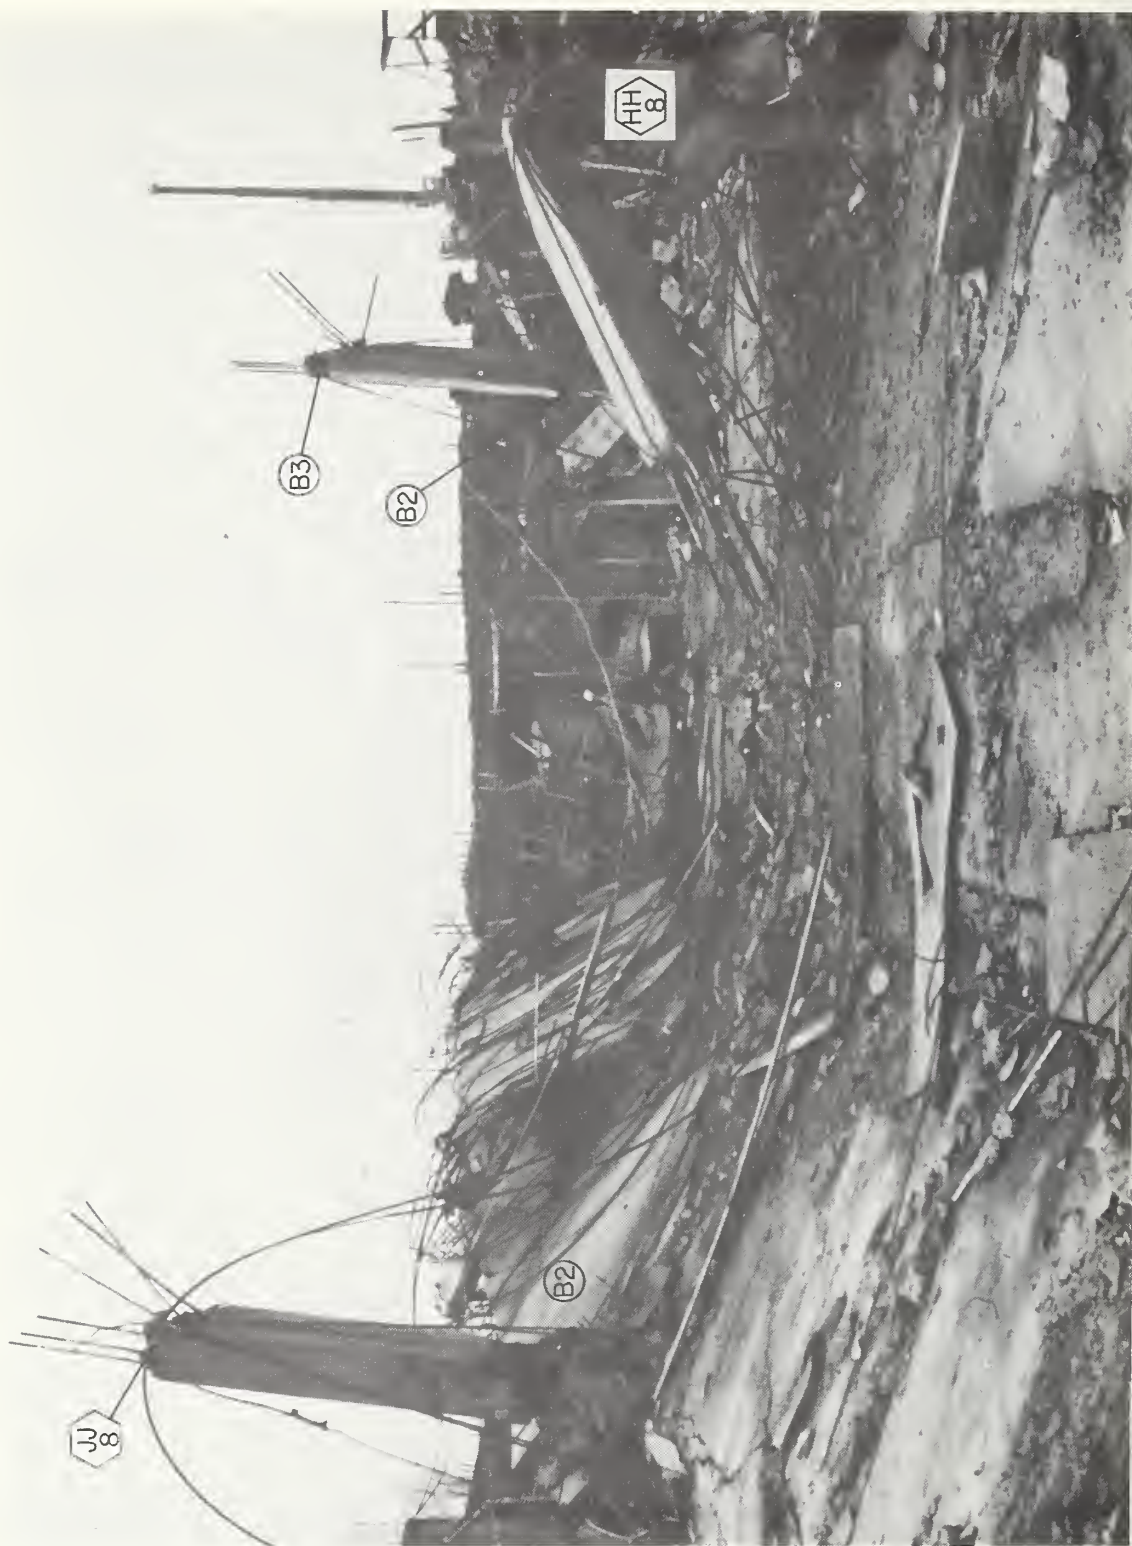
Figure 2.45 View looking west of slab B-2 between column lines HH and JJ.

The garage slabs generally came "straight" down except near the slab edges. In the latter cases the columns usually failed in bending. Figure 2.45 shows a view of slab B-2 with the edge between columns JJ-5 and JJ-8 visible on the left. The view of this edge from the south is shown in figure 2.46. Note that the columns failed at the B-3 level. Formwork can be seen lying on top of the slab B-3. These forms apparently were in place under slab B-2.

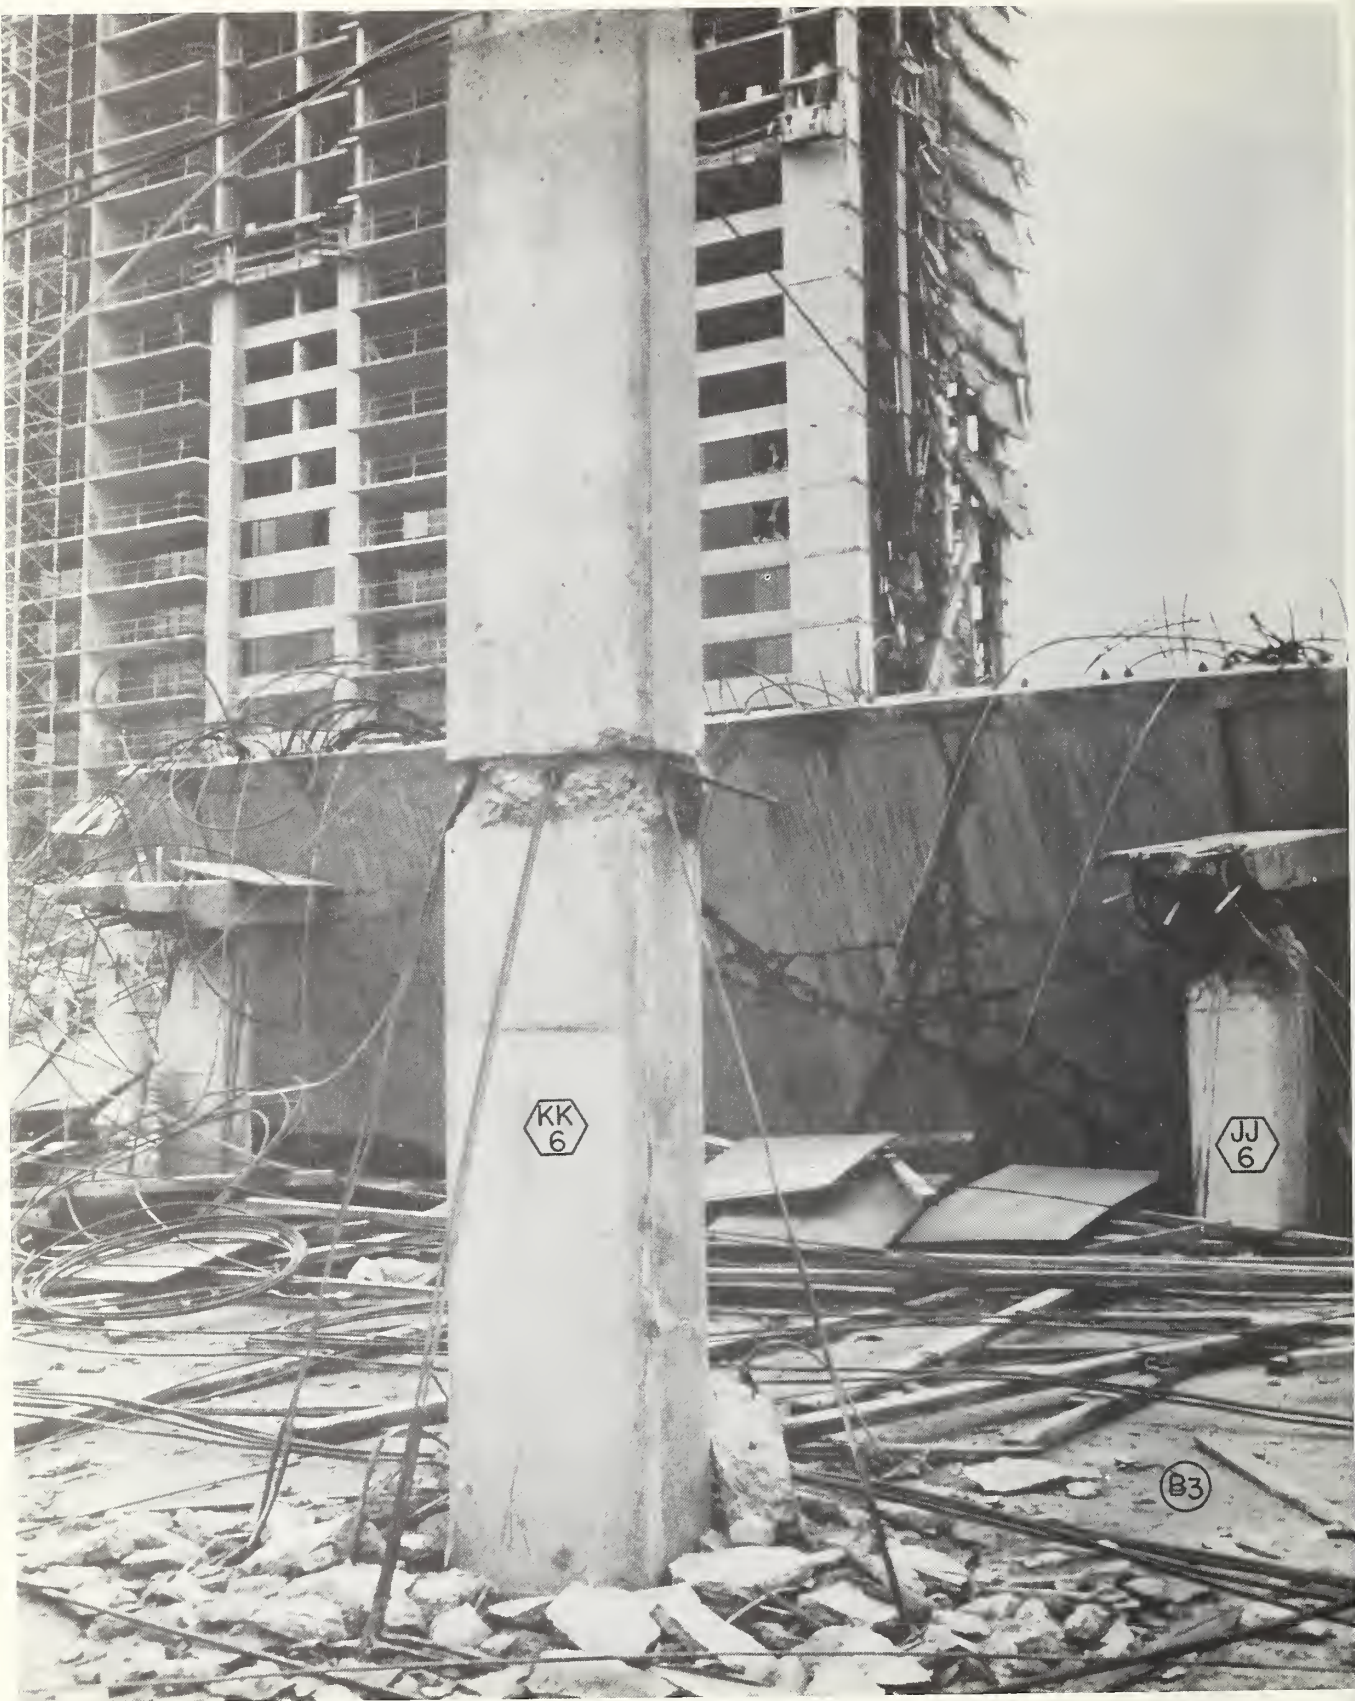
Figure 2.47 Typical column in the parking garage.

Column KK-6 may be seen in figure 2.47. Once again the shear cone usually associated with a slab punching failure is not visible in the photograph. Note the ruptured reinforcing bars at the base of the column. These are shown more clearly in figure 2.48 (but not for column KK-6).

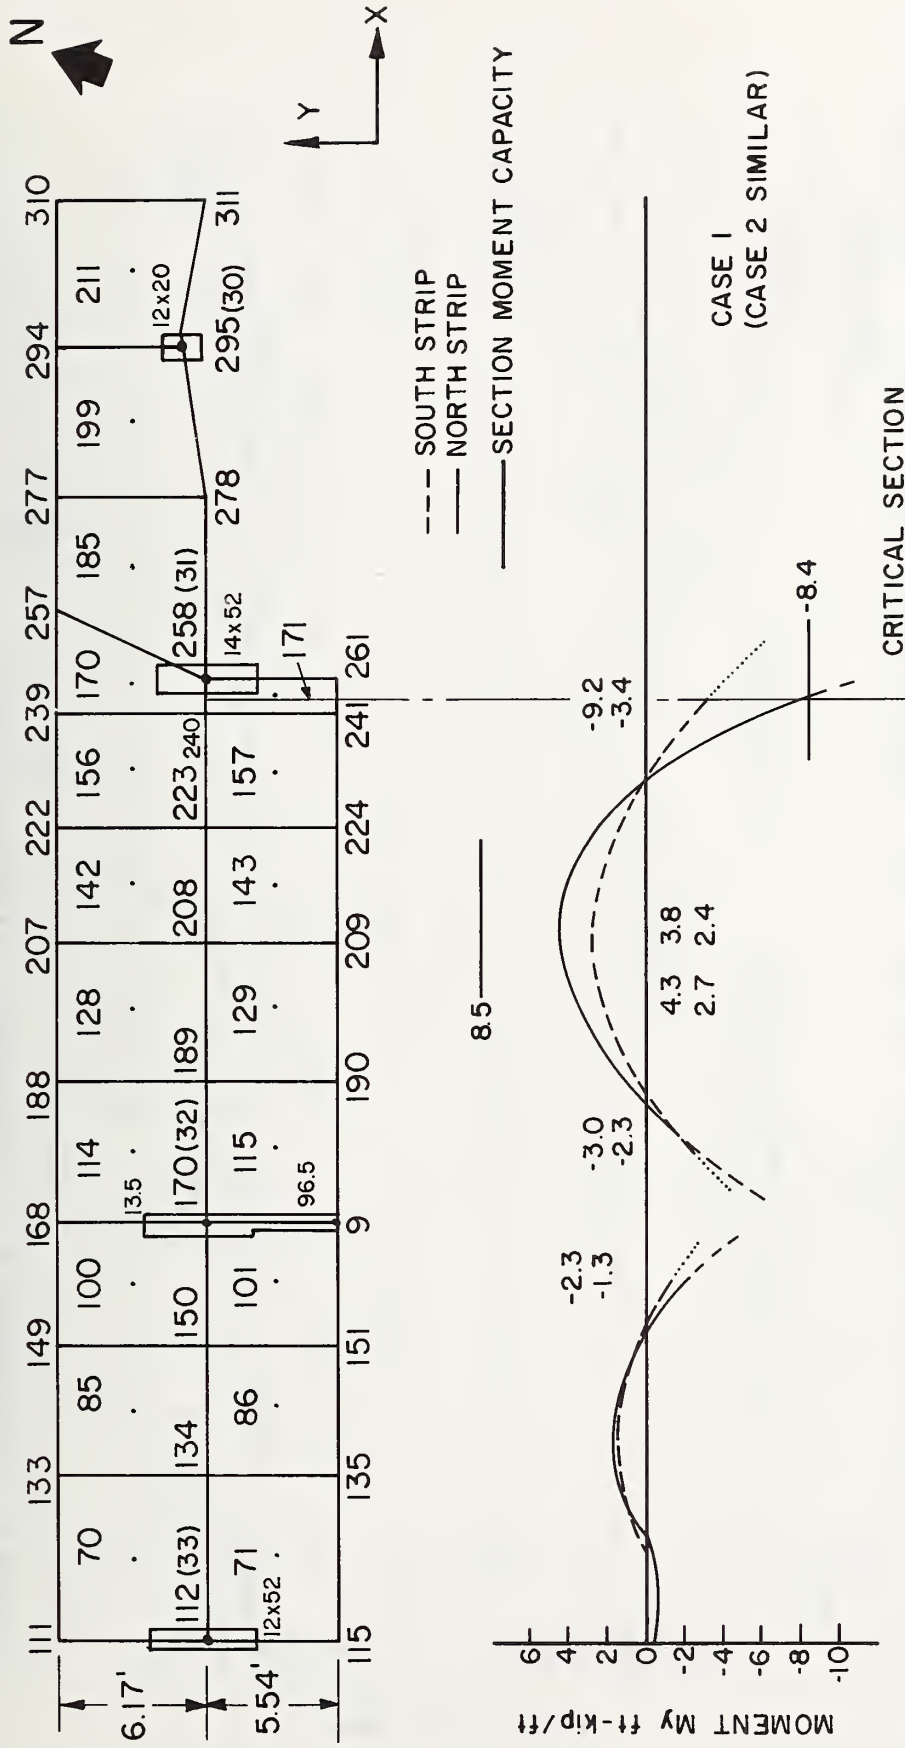
Figure 4.6 MOMENTS IN COLUMN STRIP 33-32-31-30

Altogether four column strips were investigated. Of these, the strip shown in figure 4.6 was found to be the one most critical in flexure. Case 1 negative moment at the critical section near column 31 (node 258) was about 9.2 ft-kips/ft. The moment capacity of the

slab at this section, determined on the basis of reinforcement details in the contract drawings, was found to be about 8.4 ft-kips/ft, indicating that the flexural capacity of the section was exceeded by about 10 percent. In this case, as in all other cases investigated, the flexural capacity of the section was found to be governed by yielding of the tensile reinforcement rather than by crushing of concrete in compression. Thus it is estimated that yielding occurred in the slab at column 31 and yielding propagated toward column 83 (see figure 4.1). However, this local yielding is not sufficient to cause a collapse mechanism of the 23rd story floor slab. In fact, a flat slab construction of the type used in Skyline Plaza building is generally recognized to have considerably greater moment capacity than the capacity at which the first local yielding occurs because of its inherent ability to redistribute peak moments to neighboring regions through the mechanism of yielding.
